APPENDIX 'B'

**FIRE STATIONS AND MAJOR APPARATUS
CHATHAM KENT FIRE STATIONS AND VEHICLE INVENTORY**

CHATHAM KENT FIRE STATIONS AND MAJOR APPARATUS INVENTORY

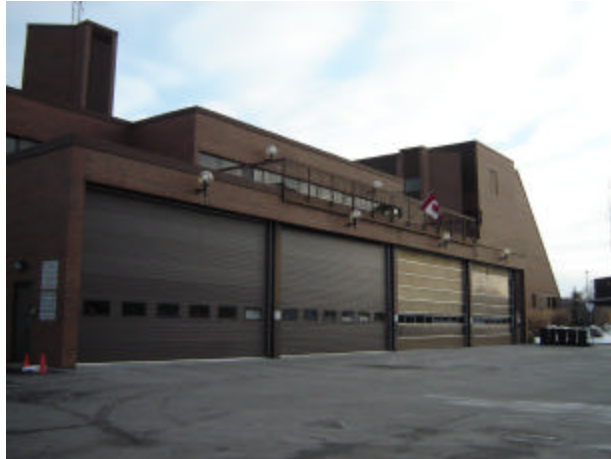
Station 1

The station has 4 double bays with crew quarters and administrative offices attached to the municipal office complex. The crew quarters are cramped and do not have any facilities for staff training. There are no separate female washroom, shower and locker room facilities. The administrative offices are cramped with limited office and storage space. The station does not have an exhaust ventilation system to prevent vehicle exhaust from migrating to crew quarters and offices. A hose tower is located at the rear of the station. At the time of the audit, the east overhead door was not operating and had been out of service for a number of weeks.

The Fire Prevention Division is located in the old communications room on the mezzanine and is not large enough to adequately accommodate all of the staff. The mezzanine also acts as a museum containing fire department memorabilia. There is a small work shop and an SCBA room. There is not adequate storage for consumable materials that must be distributed to the 19 fire stations.

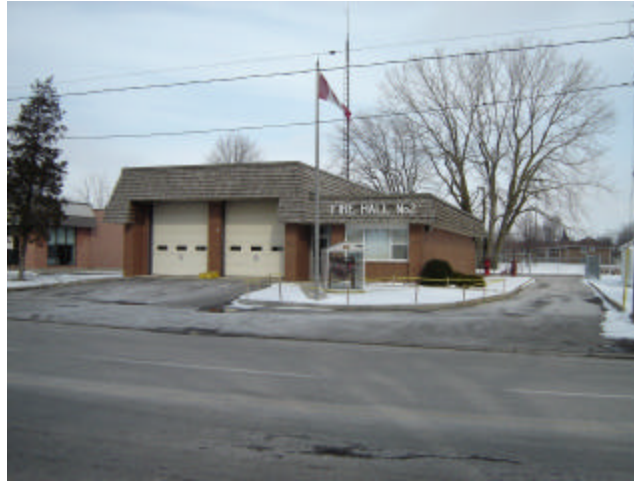
Station 2

Two bay fire station with crew quarters. The bays are short and can only accommodate 2 vehicles. The station cannot accommodate more than 4 staff. The facility is cramped. The captain's office is located in the front entrance. There are no separate female washroom, shower and locker room facilities. There is no vehicle exhaust extraction system.

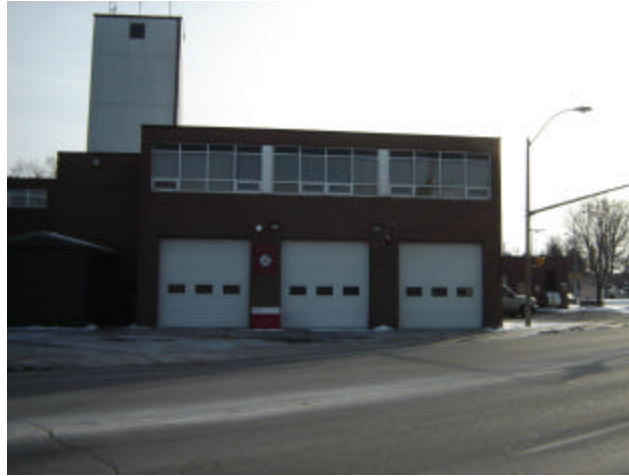
Station 3

Three bay two storey structure attached to a larger municipal building. Sprinkler protected. There are crew quarters and a training room. The work shop contains an SCBA bottle filling facility. The building is equipped with a vehicle exhaust system. The bays are small and the door height is too low. Unit 3-14 can only be parked in the centre bay and is 2-3 inches lower than the door at full height. The ladder will hit the door if there is an accumulation of snow on the ramp. Unit 3-14 cannot make a left turn when exiting the building without making a three point turn. The station opens directly onto the street and there is no ramp to park the vehicles. The traffic must be stopped in order to back the vehicles into the station.

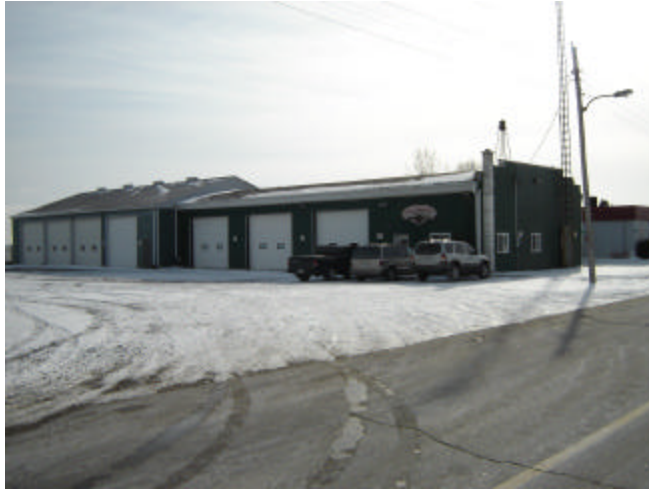
Station 4

Seven bay station. Steel siding with steel and wood roofs. The structure is poorly insulated and has numerous unsealed openings that create a substantial heat loss. The offices are partially demolished. The firefighters use the bay area for training and meetings since there is no proper meeting/training room. The unused bay areas are used for miscellaneous storage. The building is in need of repair.

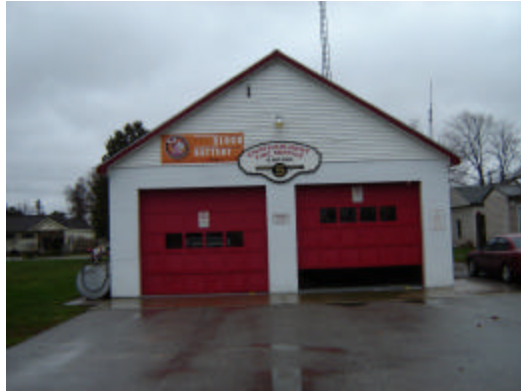
Station 5

Block two bay fire station with meeting room and washroom. Wood roof with asphalt shingles. This building is un-insulated, in poor condition and in need of replacement. The bays are small and the station is not large enough to house all of the equipment. The rescue van must be housed in a rented unheated garage that is also in disrepair.

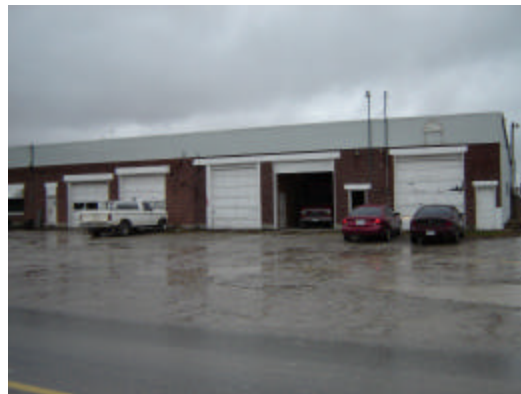
Rented Unheated Garage for Rescue Van

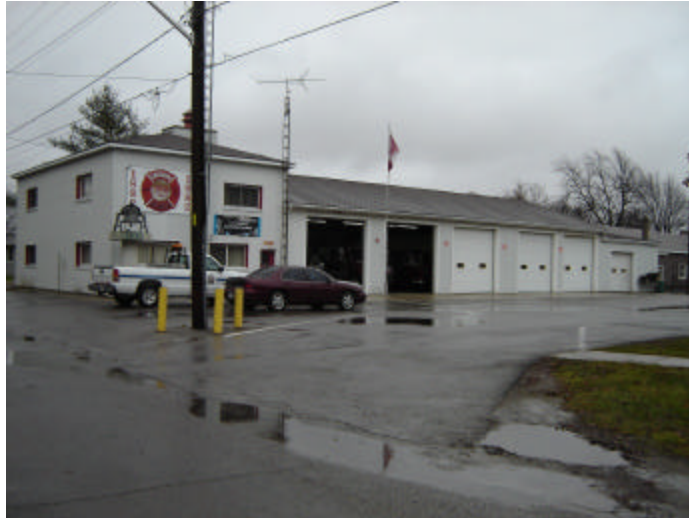
Station 6

Block structure with metal siding. Two storey office/meeting area with a 6 bay garage. Wood frame floors and roof. Asphalt shingles.

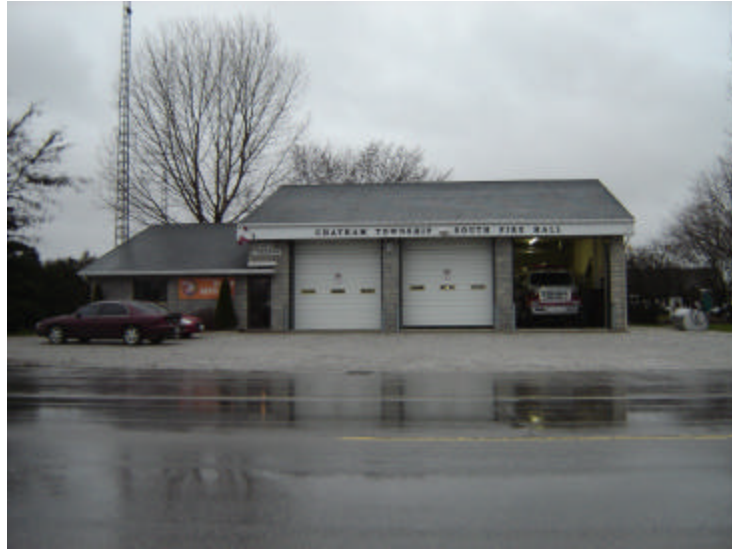
Station 7

Three bay block building with meeting room and washroom. Wood frame roof with asphalt shingles.

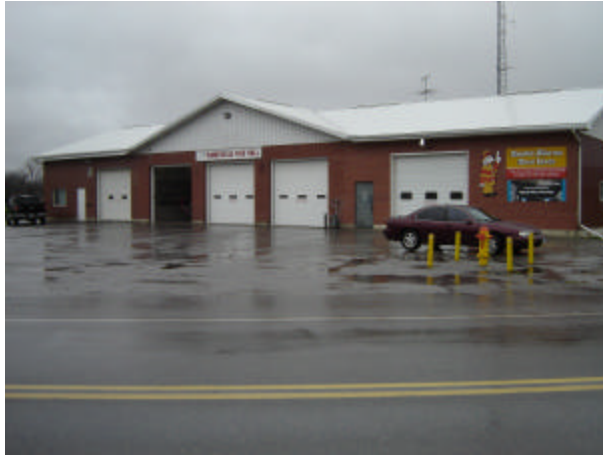
Station 8

Four bay brick and block construction with steel roof. Meeting room and washroom. The building also houses an ambulance station that is operated separately from the fire department.

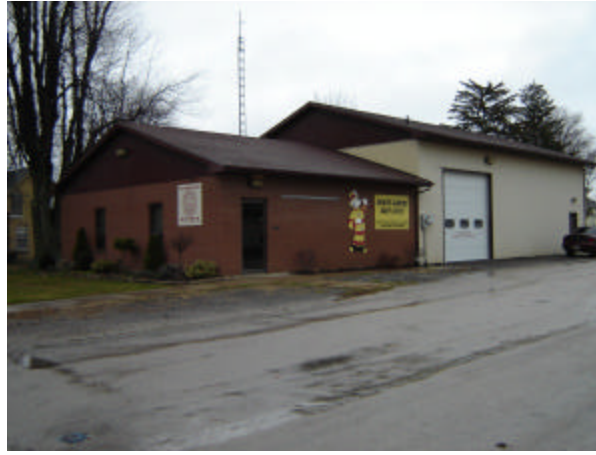
Station 9

Three bay steel siding garage. The bays are just large enough to accommodate the existing vehicles. Brick office/meeting room and washroom. Wood frame roof with asphalt shingles.

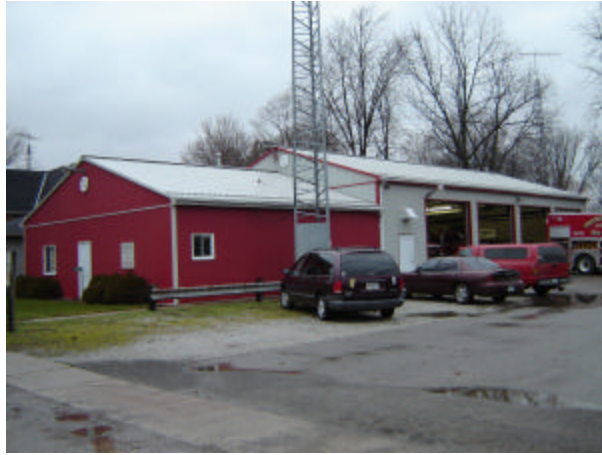
Station 10

Four bay combustible construction building with steel siding and steel roof. Meeting room, offices and washrooms.

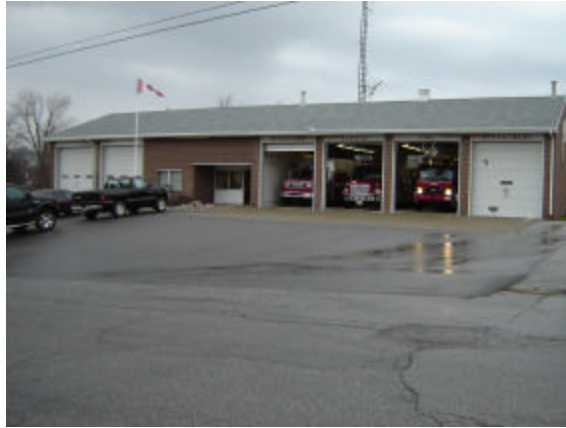
Station 11

Five bay brick and block building. Combustible construction roof with asphalt shingles. Offices, meeting room and washroom. Exposed sprayed on foam insulation in truck bays. Building is equipped with an intrusion alarm.

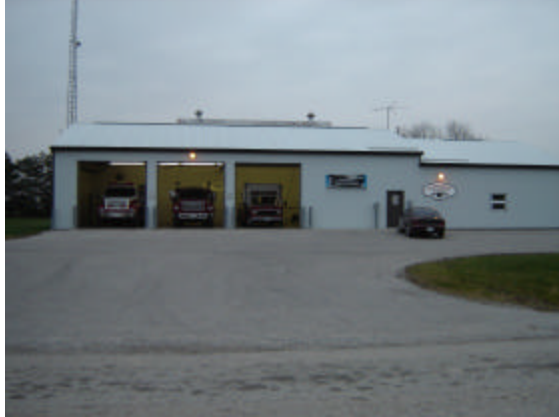
Station 12

Three bay station with meeting room, office and washroom. Steel clad building with steel roof.

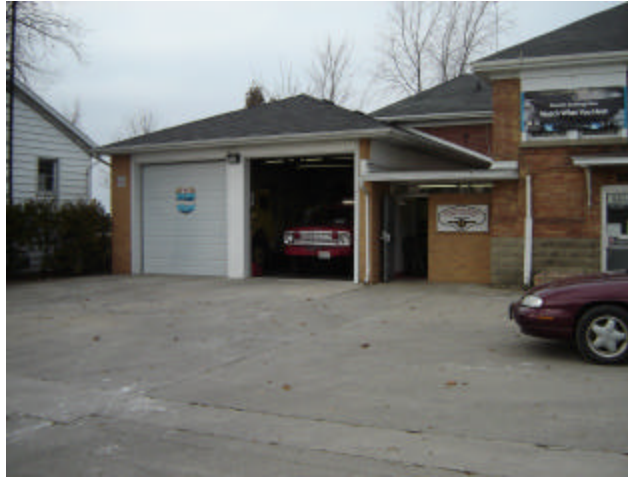
Station 14

Two bay station connected to the former municipal building (library). Combustible construction with brick exterior. Wood roof with asphalt shingles. The station is cramped and cannot accommodate two fire apparatus and the rescue boats and trailers. The large rescue boat is kept moored at the marina. A larger fire station is required to accommodate the required fire and rescue apparatus.

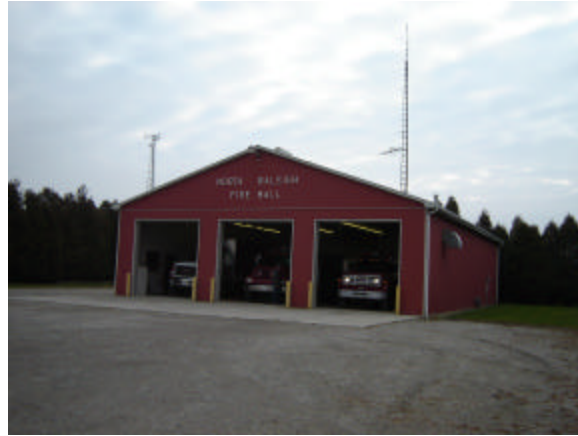
Station 15

Three bay garage with meeting room, office and washroom. Steel siding with steel roof.

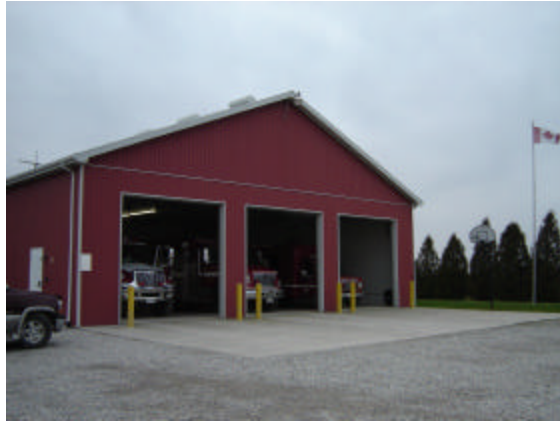
Station 16

Three bay garage with meeting room, office and washroom. Steel siding with steel roof.

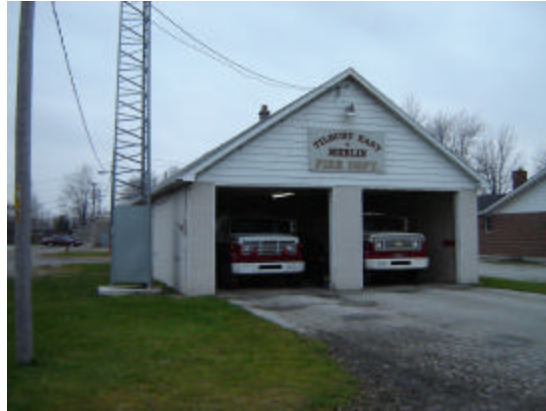
Station 17 Storage Garage

The station is located in two separate structures. The storage garage is block construction with wood roof and asphalt shingles. The garage is used to store 3 vehicles and is too small for the vehicles. Vehicles must be moved out of the building to conduct routine checks. The building is in poor condition and in need of replacement. The office/meeting building is of combustible construction with brick exterior and asphalt shingle roof. The building is in need of repairs.

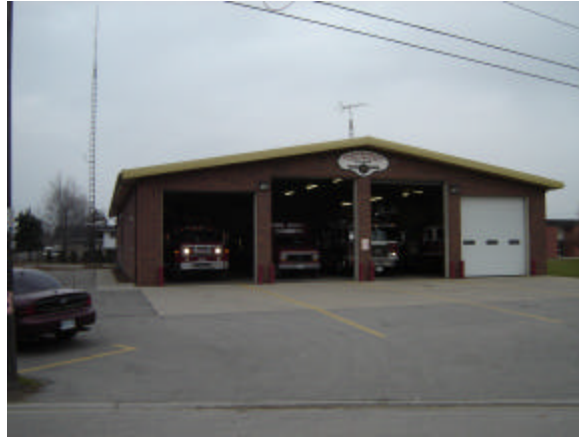
Station 18

Four bay brick and block construction station. Steel roof with tar and gravel.

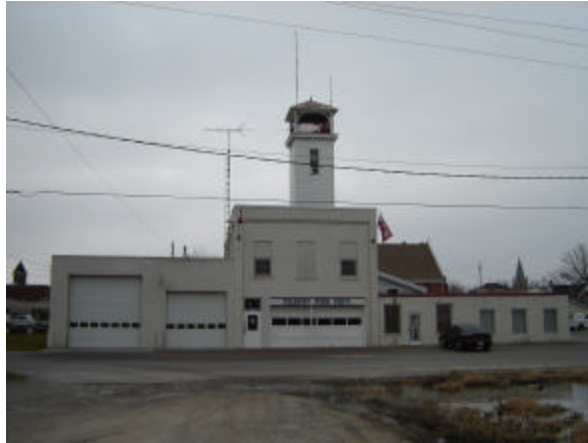
Station 19

Five bay fire station with second floor meeting room, offices and washroom. The building is a combination of combustible and non-combustible construction with block and stucco exterior and tar and gravel roof. Wood construction hose tower. The building is old and in need of repair. Some offices must be accessed through the furnace room. The old main bay is used for public visits and is not used for vehicles.

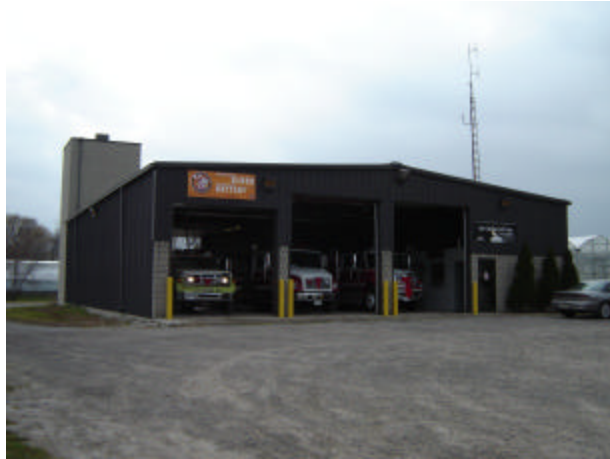
Station 20

Three bay station with offices, meeting room and washrooms. Block and steel siding exterior with steel roof.
